DEPARTMENT OF NATURAL RESOURCES
DIVISION OF OIL, GAS AND MINING

March 13, 1995

RE: Site Inspection, Jumbo Mining Company, Drum Mine, M/027/007, Millard County, Utah

Purpose of Inspection: To examine the conditions of the site and assess the amount of topsoil available for reclamation.

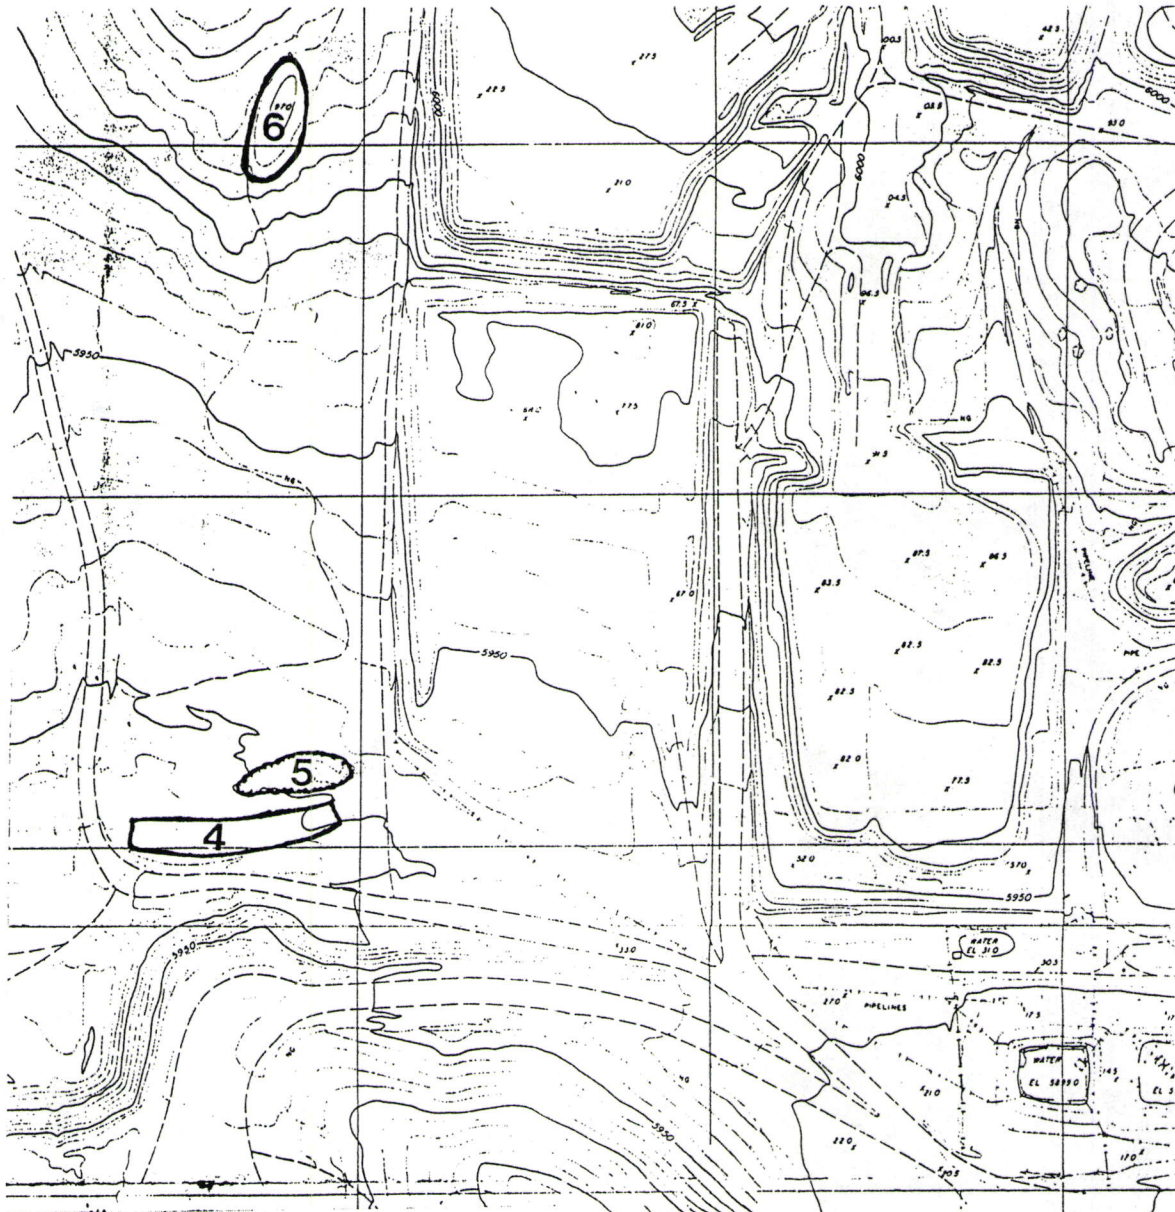
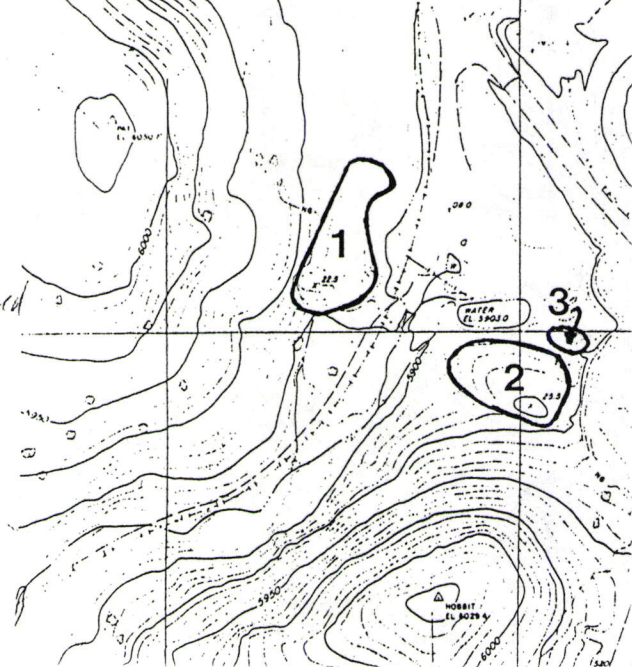
SOIL STOCKPILE AREAS
DRUM MINE

actually 2 small areas

not surveyed

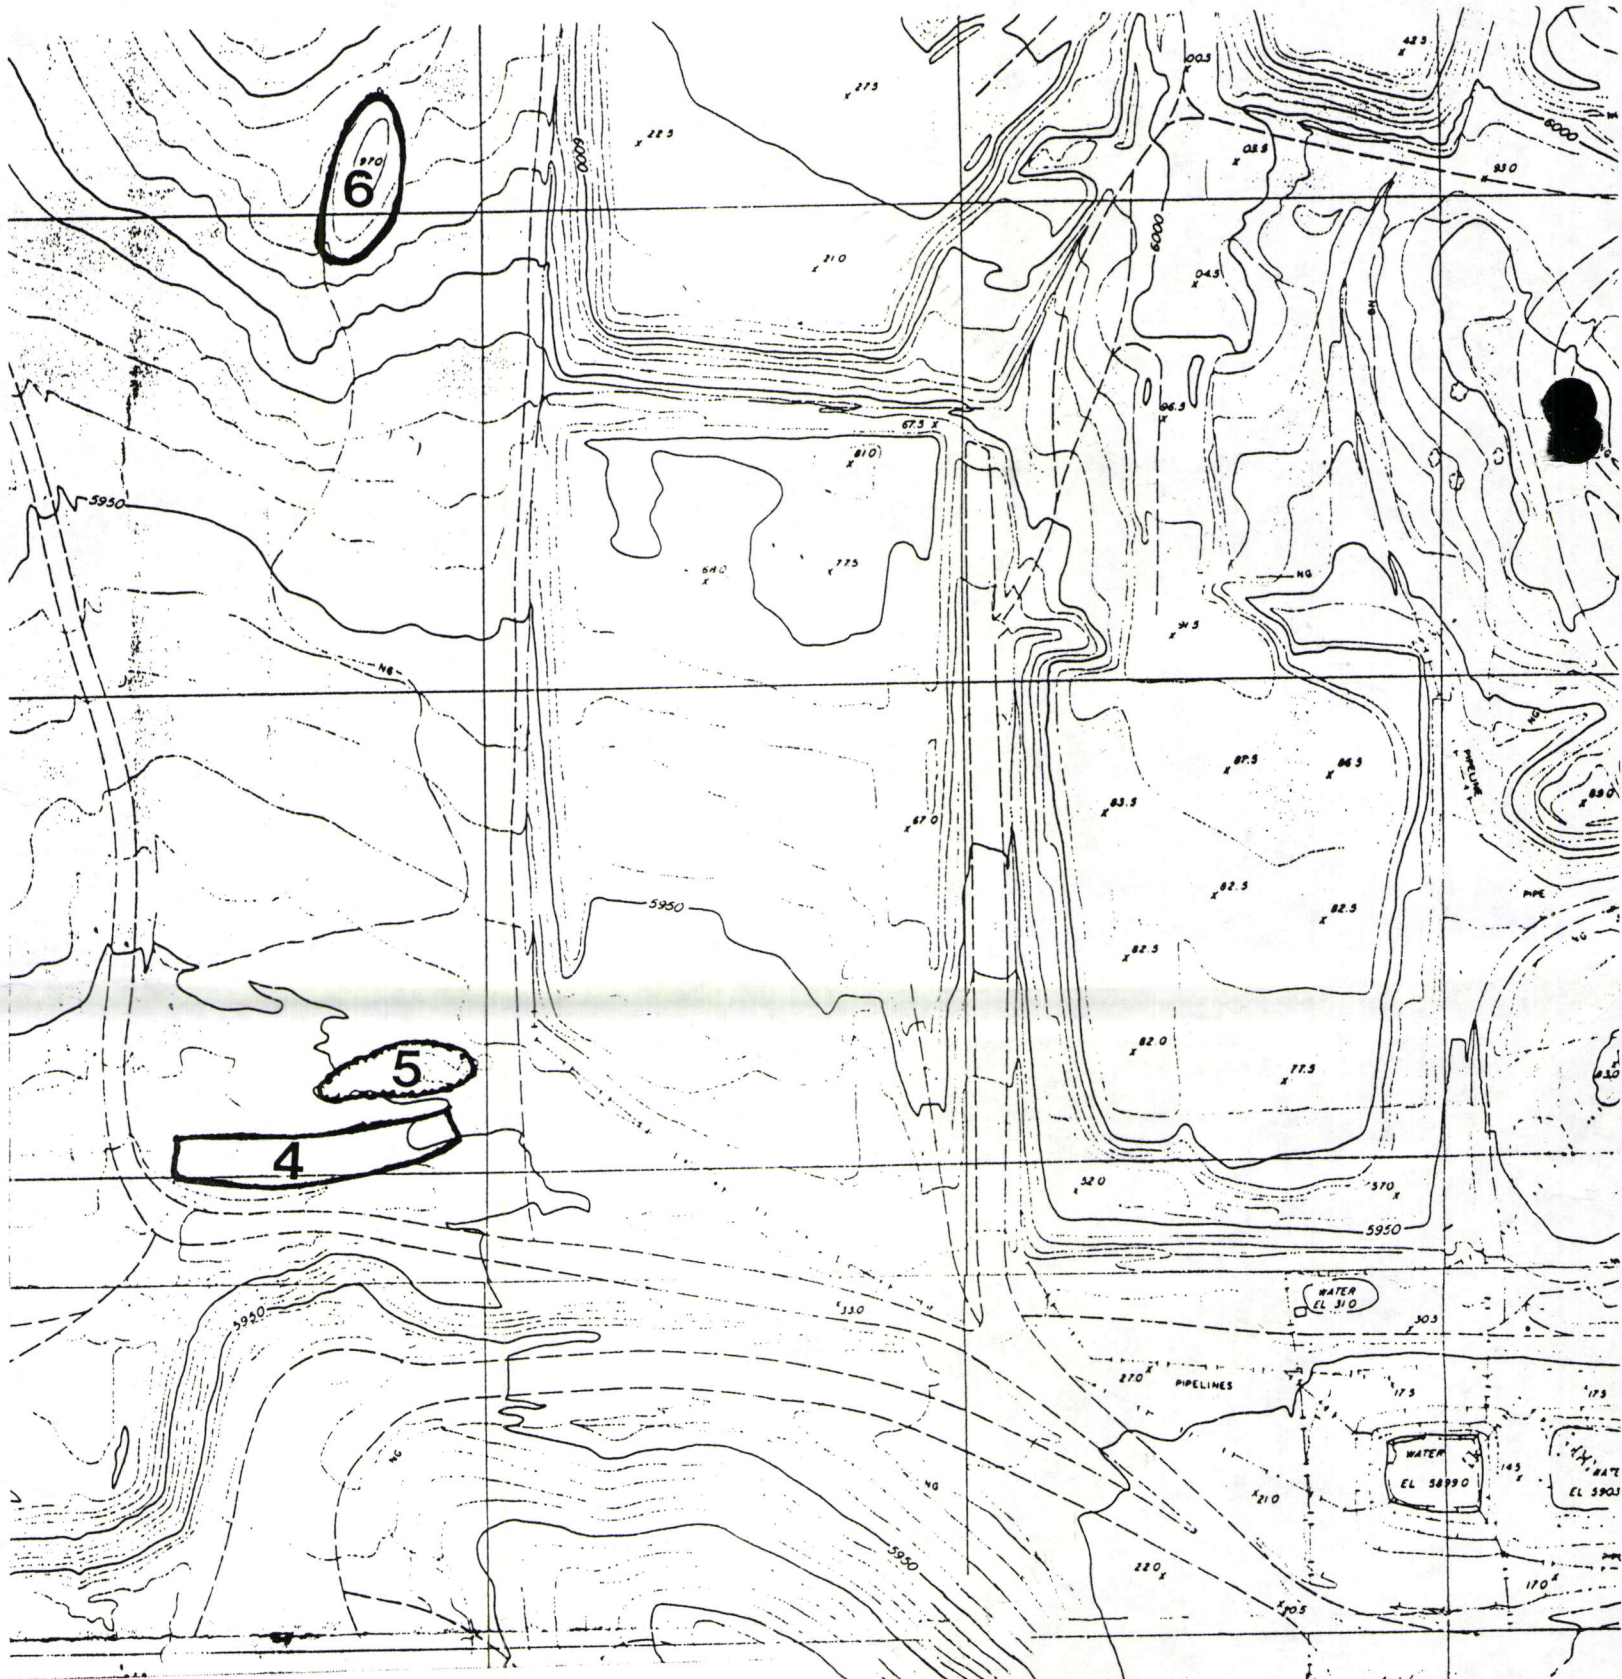
SOIL STOCKPILE AREAS
DRUM MINE

*factually
2 small
areas*

Area 3 = 100 yards *not surveyed*
